# Historical Sample of Damage from Natural Gas Transmission Pipeline Explosions

August 14, 2017

J. E. Gillett  
Rev 0

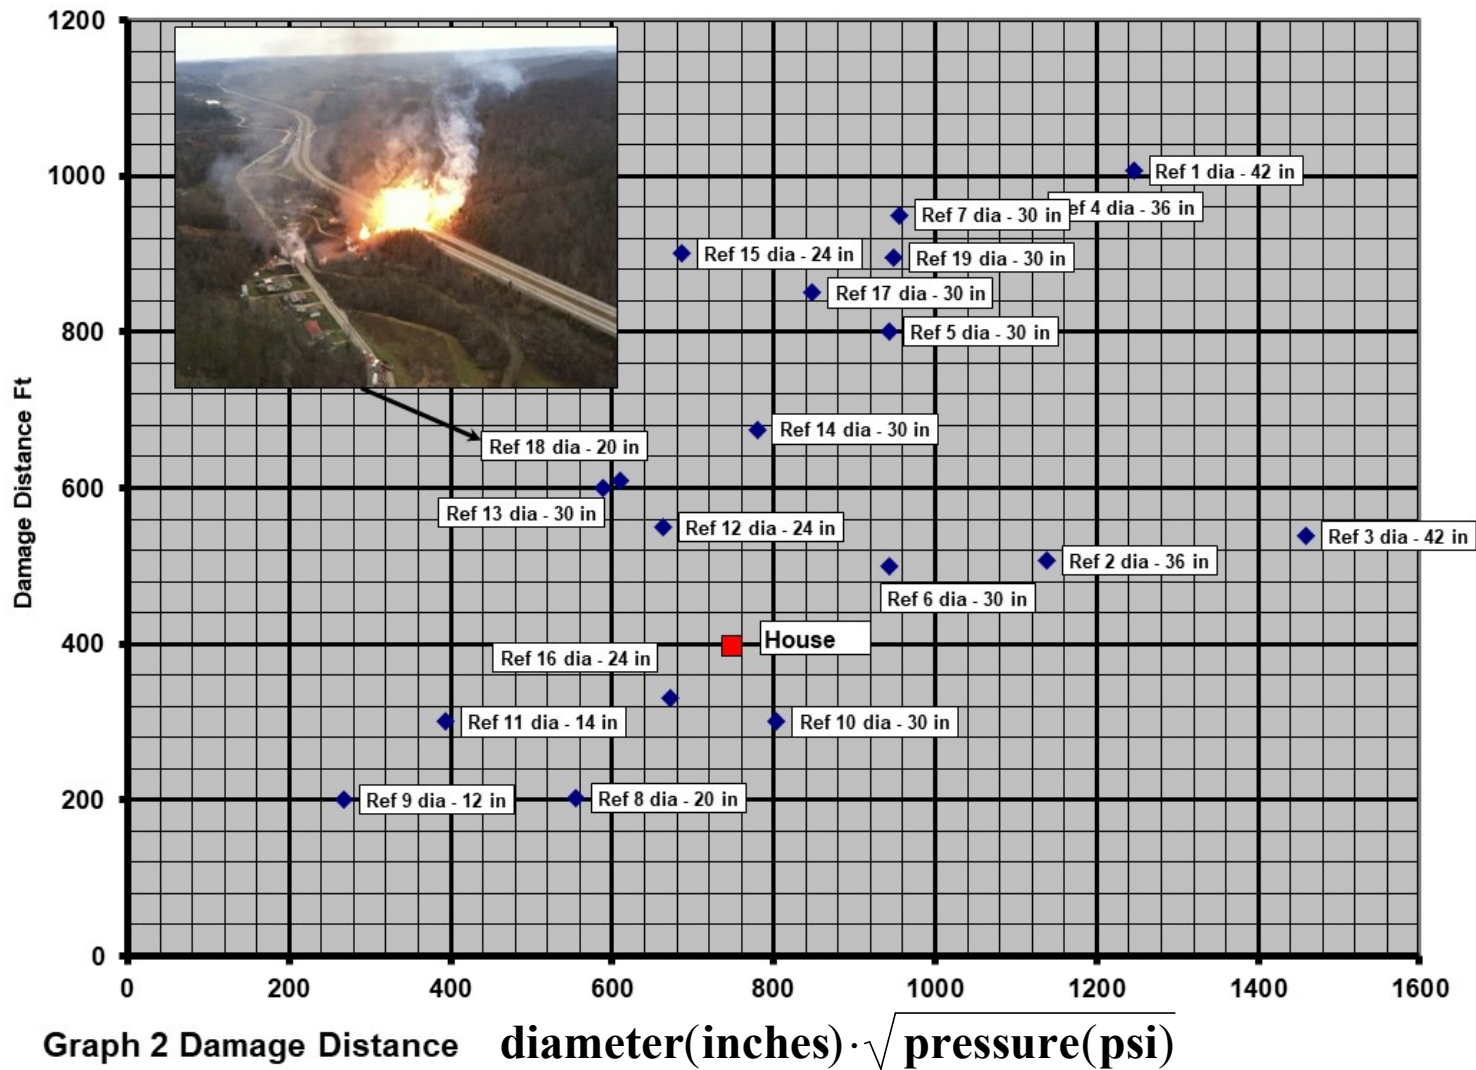
**Graph 2**, “Damage Distance”, compares the distance to observed damage among the historical sample of incidents. This graph correlates the damage distance to the pipeline diameter times the square root of the pressure at the point of rupture. The picture insert is for the recent Sissionville incident reference 18.

The red square labeled “House” represents the likelihood of damage, based on the historical sample, to a house located 403 feet from the rupture with ignition of a 20-inch natural gas pipeline with an operating pressure of 1404 psi. Based on direct observation of damage from a natural gas pipeline with very similar circumstances that did explode (reference 18), it is concluded the house would be destroyed.

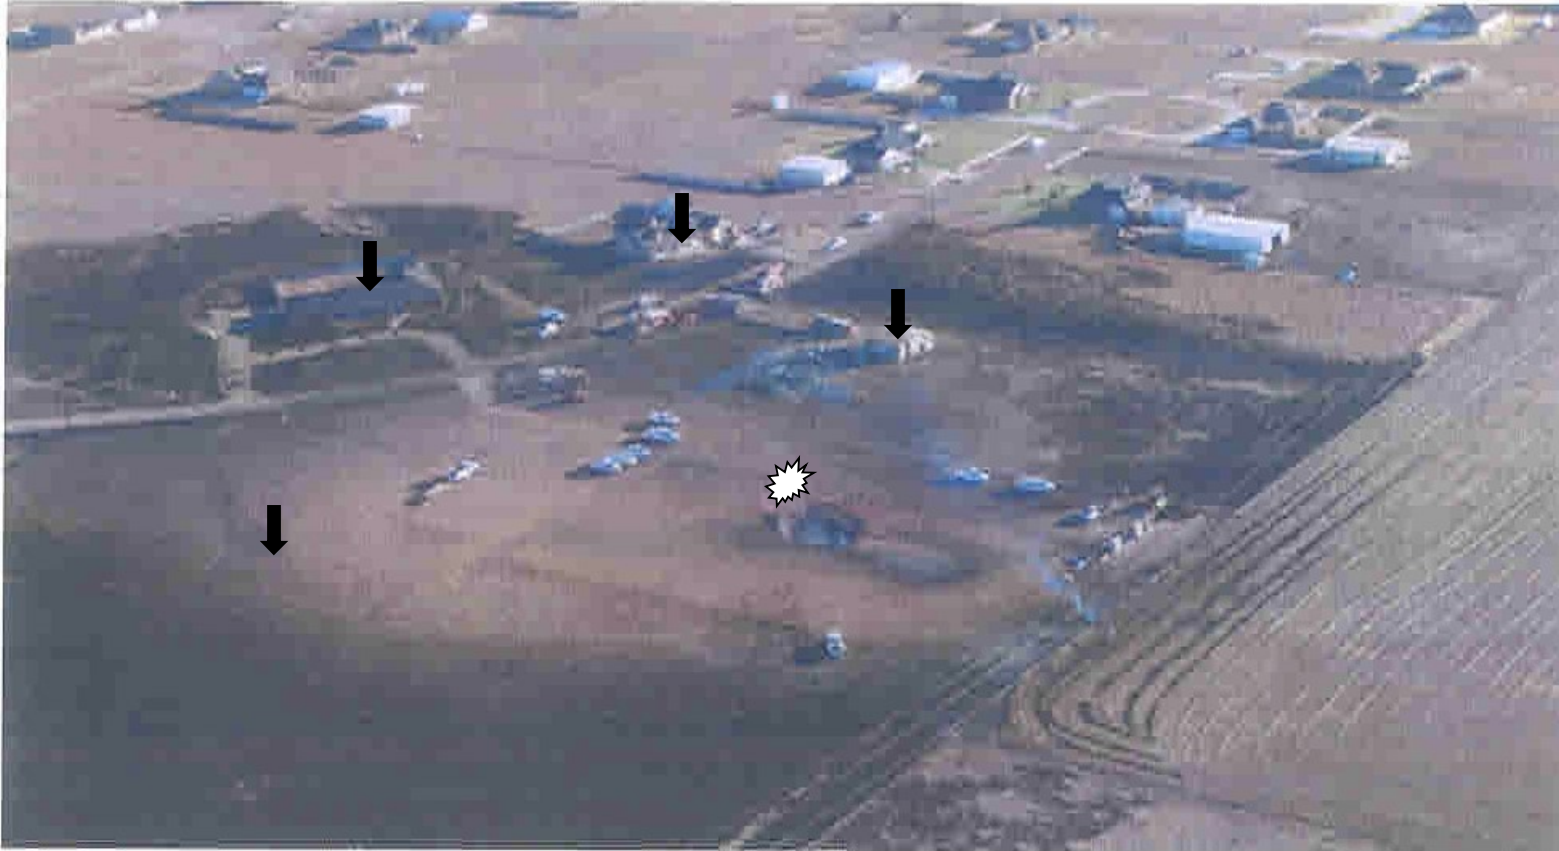
**Figure 1- Pipe Rupture 11/5/2009 Bushland Texas Ref 12**

| Table 1 Summary Of Incidents | | | | | | | | |
|---|---|---|---|---|---|---|---|---|
| 12 | 11/5/2009 | Bushland Texas | 24 | 762 | 550 | Measured Aerial | Heat Damage | Failure Investigation Report – El Paso Pipe Failure at Saddle, PHMSA 10/20/2011, Richard Lopez; Channel 10 Aerial, NTSB ; |

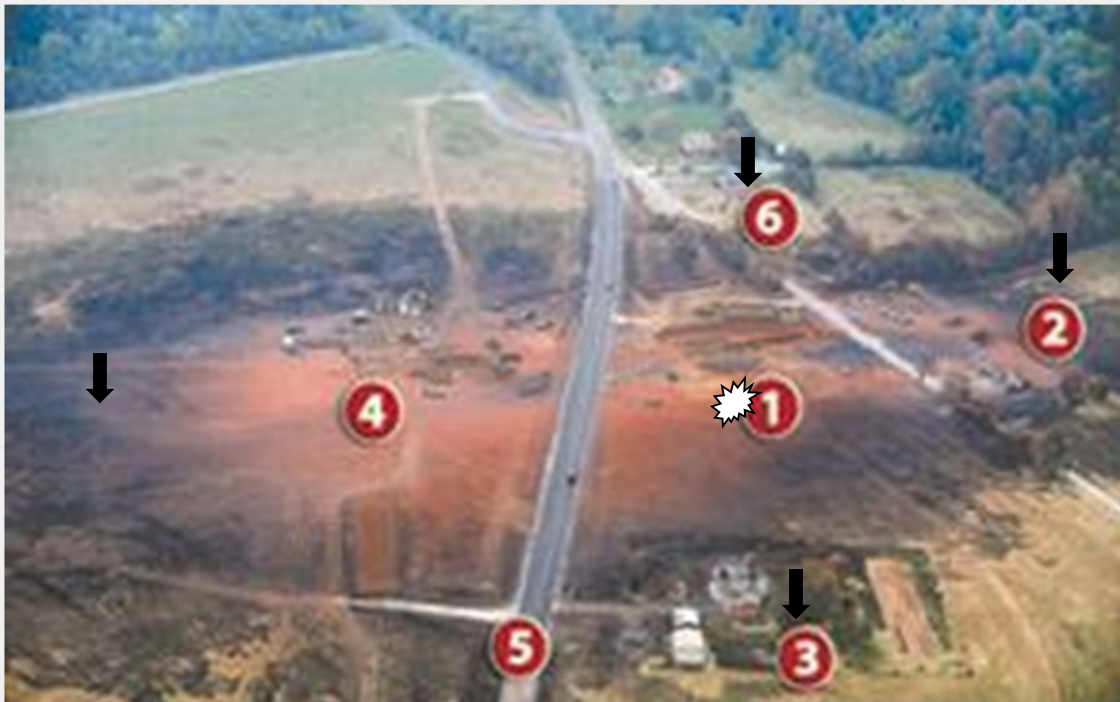
**Figure 2- Pipeline Rupture 9/ 14/2000 Appomattox Virginia Ref 17**

| Table 1 Summary Of Incidents | | | | | | | | |
|---|---|---|---|---|---|---|---|---|
| 17 | 9/14/2008 | Appomattox Virginia | 30 | 799 | 850 | Aerial Visible Damage | Burn Area | NTSB CPF 1-2008-1004H, <a href="http://www.newsadvance.com">www.newsadvance.com</a> , September 24, 2008 aerial photo; |

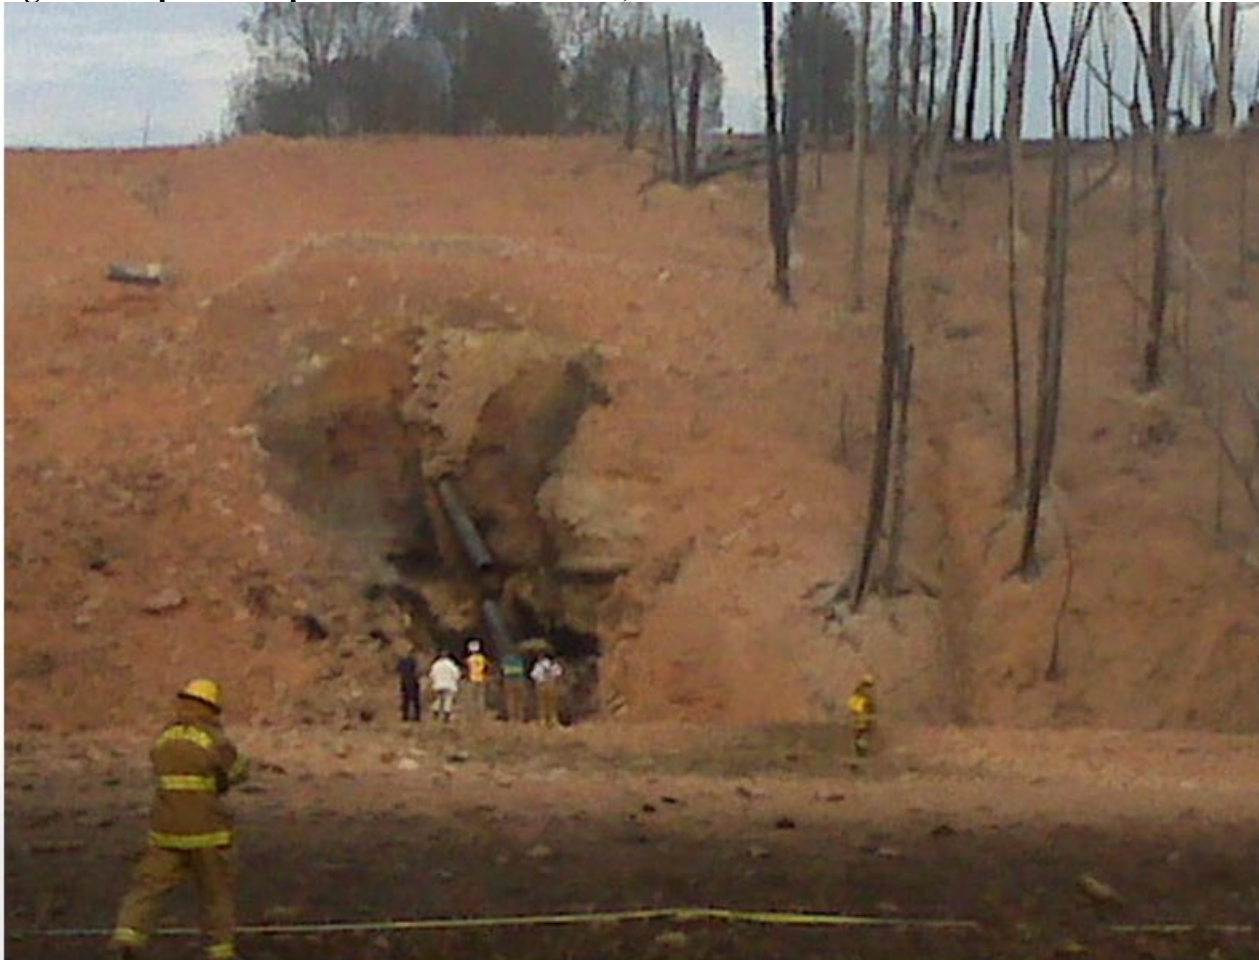
**Figure 3- Pipeline Rupture 5/5/2009 Rockville, In Ref 16**

| Table 1 Summary Of Incidents | | | | | | | | |
|---|---|---|---|---|---|---|---|---|
| 16 | 5/5/2009 | Rockville, In | 24 | 784 | 330 | Aerial Visible Damage | Burn Area | NTSB 3-2009-1009H, newspaper description The Tribune-Star, May 6, 2010, Howard Greninger; WTHI TV Website Updated Wednesday, 30 Dec 2009; <a href="http://www.wthitv.com/dpp/news/news_wthi_rockville_pipeline_explosion_under_investigation_200905061652">http://www.wthitv.com/dpp/news/news_wthi_rockville_pipeline_explosion_under_investigation_200905061652</a> |

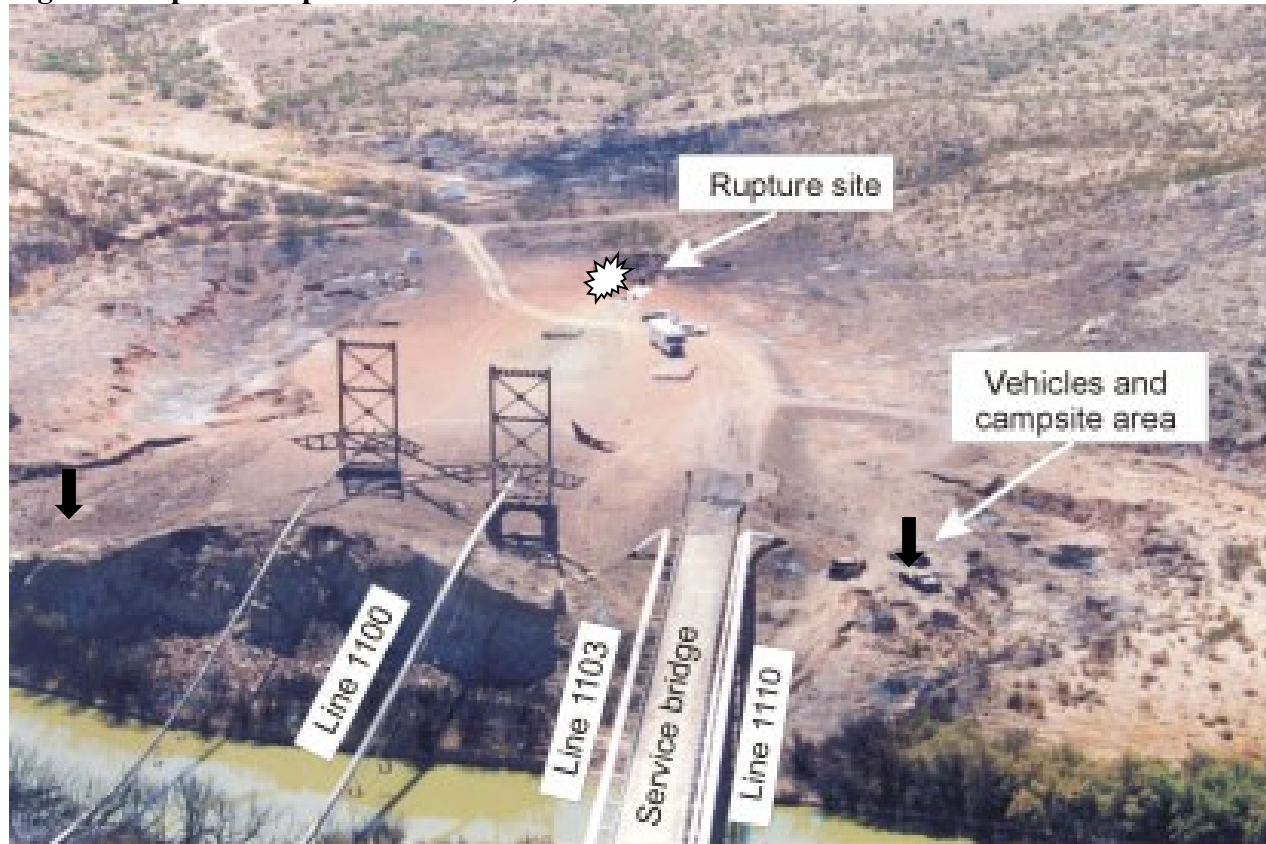
**Figure 5- Pipeline Rupture Carlsbad, New Mexico 8/10/2000 Ref 14**

| Table 1 Summary Of Incidents | | | | | | | | |
|---|---|---|---|---|---|---|---|---|
| 14 | 8/10/2000 | Carlsbad New Mexico | 30 | 675 | 675 | Measured | fatalities | NTSB/PAR-03/01, National Transportation Safety Board. 2003. Natural Gas Pipeline Rupture and Fire Near Carlsbad, New Mexico, August 19, 2000. Pipeline Accident Report NTSB/PAR-03/01. Washington, D.C. Feb 11, 2003; |

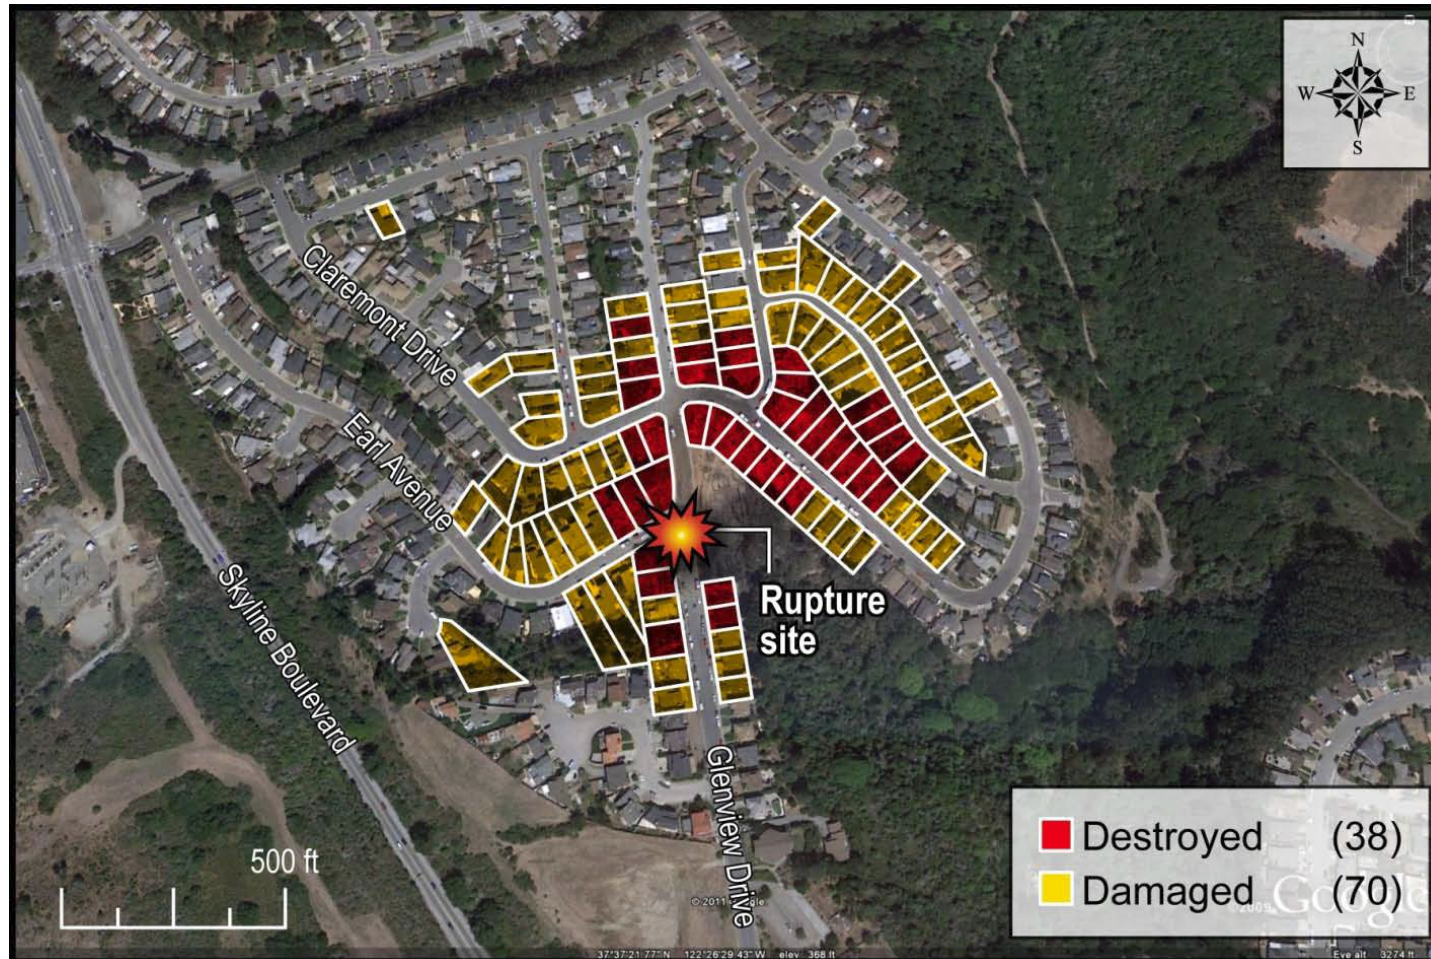
Figure 6- Pipeline Rupture 9/9/2010 San Bruno, Ca Ref 13

| Table 1 Summary Of Incidents | | | | | | | | |
|---|---|---|---|---|---|---|---|---|
| 13 | 9/9/2010 | San Bruno Ca | 30 | 386 | 600 | Measured Aerial | Houses major damage, Addresses | NTSB/PAR-11/01; Aerial <a href="http://www.mercurynews.com/bay-area-news/ci-16045510">www.mercurynews.com/bay-area-news/ci-16045510</a> , September 17, 2010; NTSB/PAR-11/01, National Transportation Safety Board. 2011. Pacific Gas and Electric Company Natural Gas Transmission Pipeline Rupture and Fire, San Bruno, California, September 9, 2010. Pipeline Accident Report NTSB/PAR-11/01. Washington, DC. August 30, 2011; |

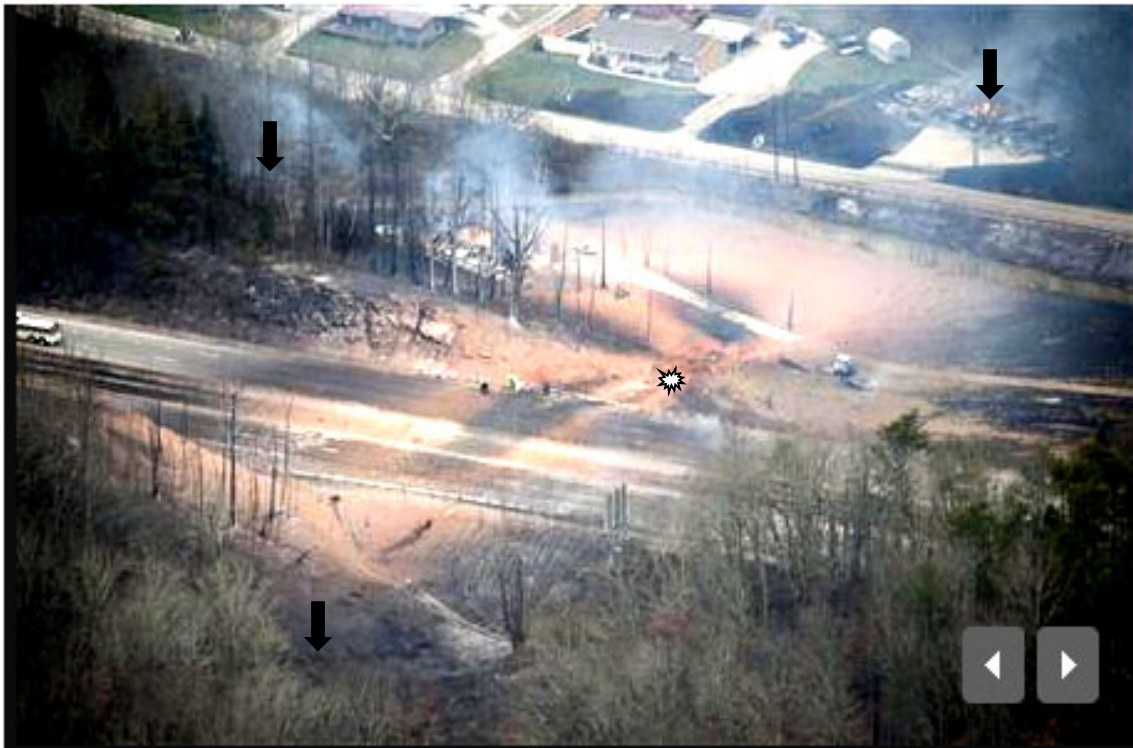
**Figure 8- Pipeline Rupture Sissonville, West Virginia, 12/11/2012**

“The escaping high-pressure natural gas ignited. Fire damage extended nearly 1,100 feet along the pipeline right-of-way and covered an area about 820 feet wide. Three houses were destroyed by the fire, and several other houses were damaged. There were no fatalities or serious injuries; however, Interstate 77 was closed for 19 hours until about 800 feet of thermally damaged road surface was replaced.”

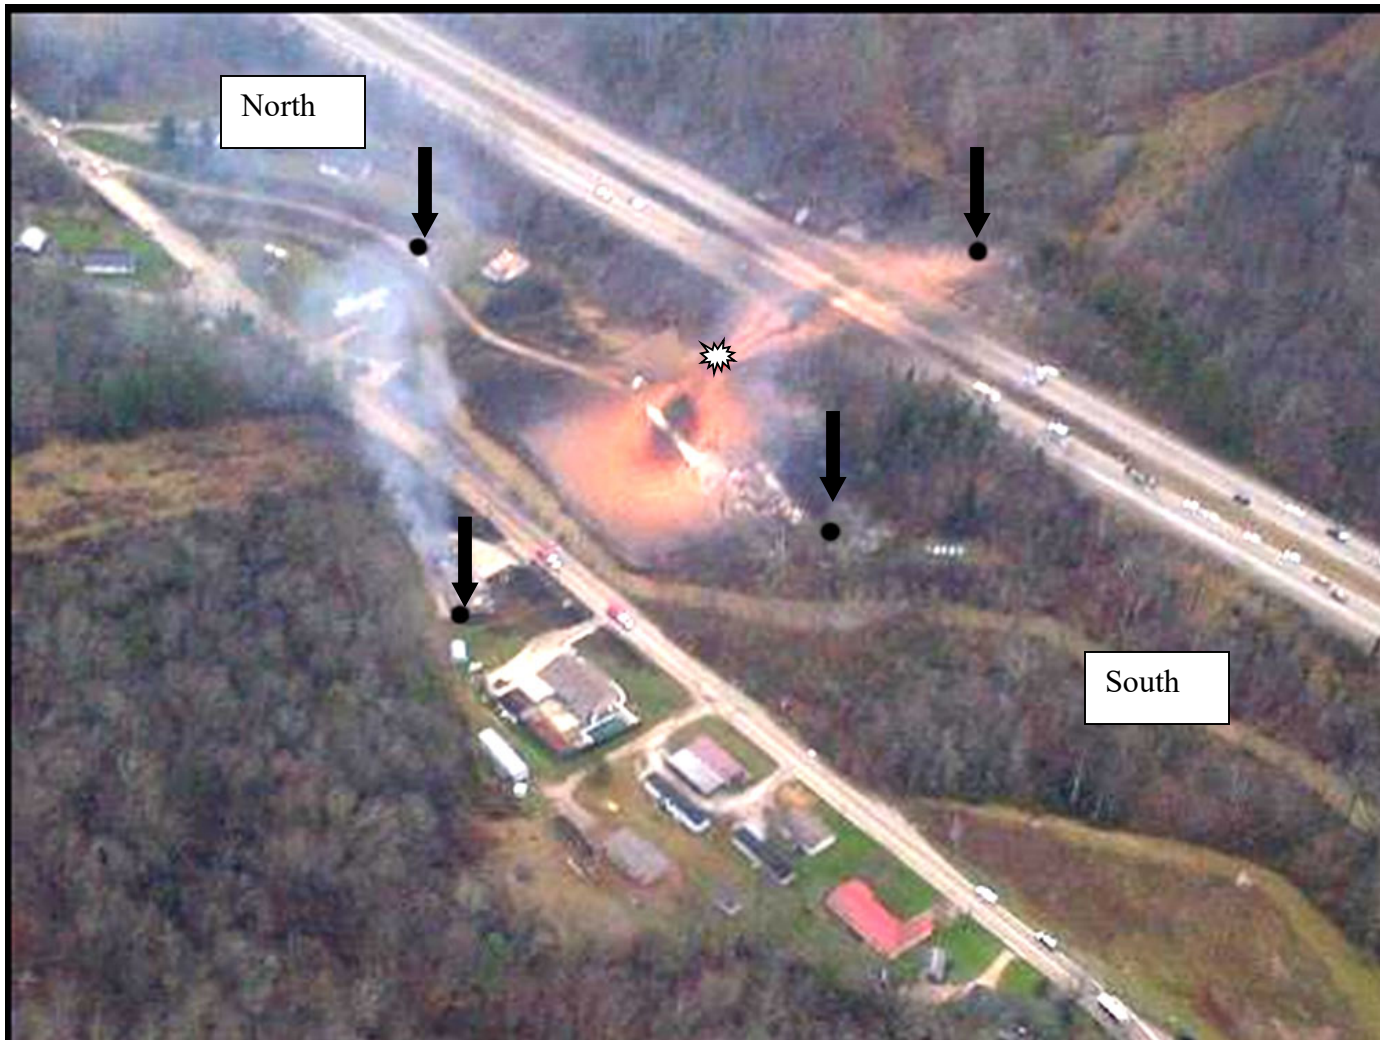
Looking From the East toward the West, Sissonville, West Virginia. Note the large areas of baked soil and scorched I-77.

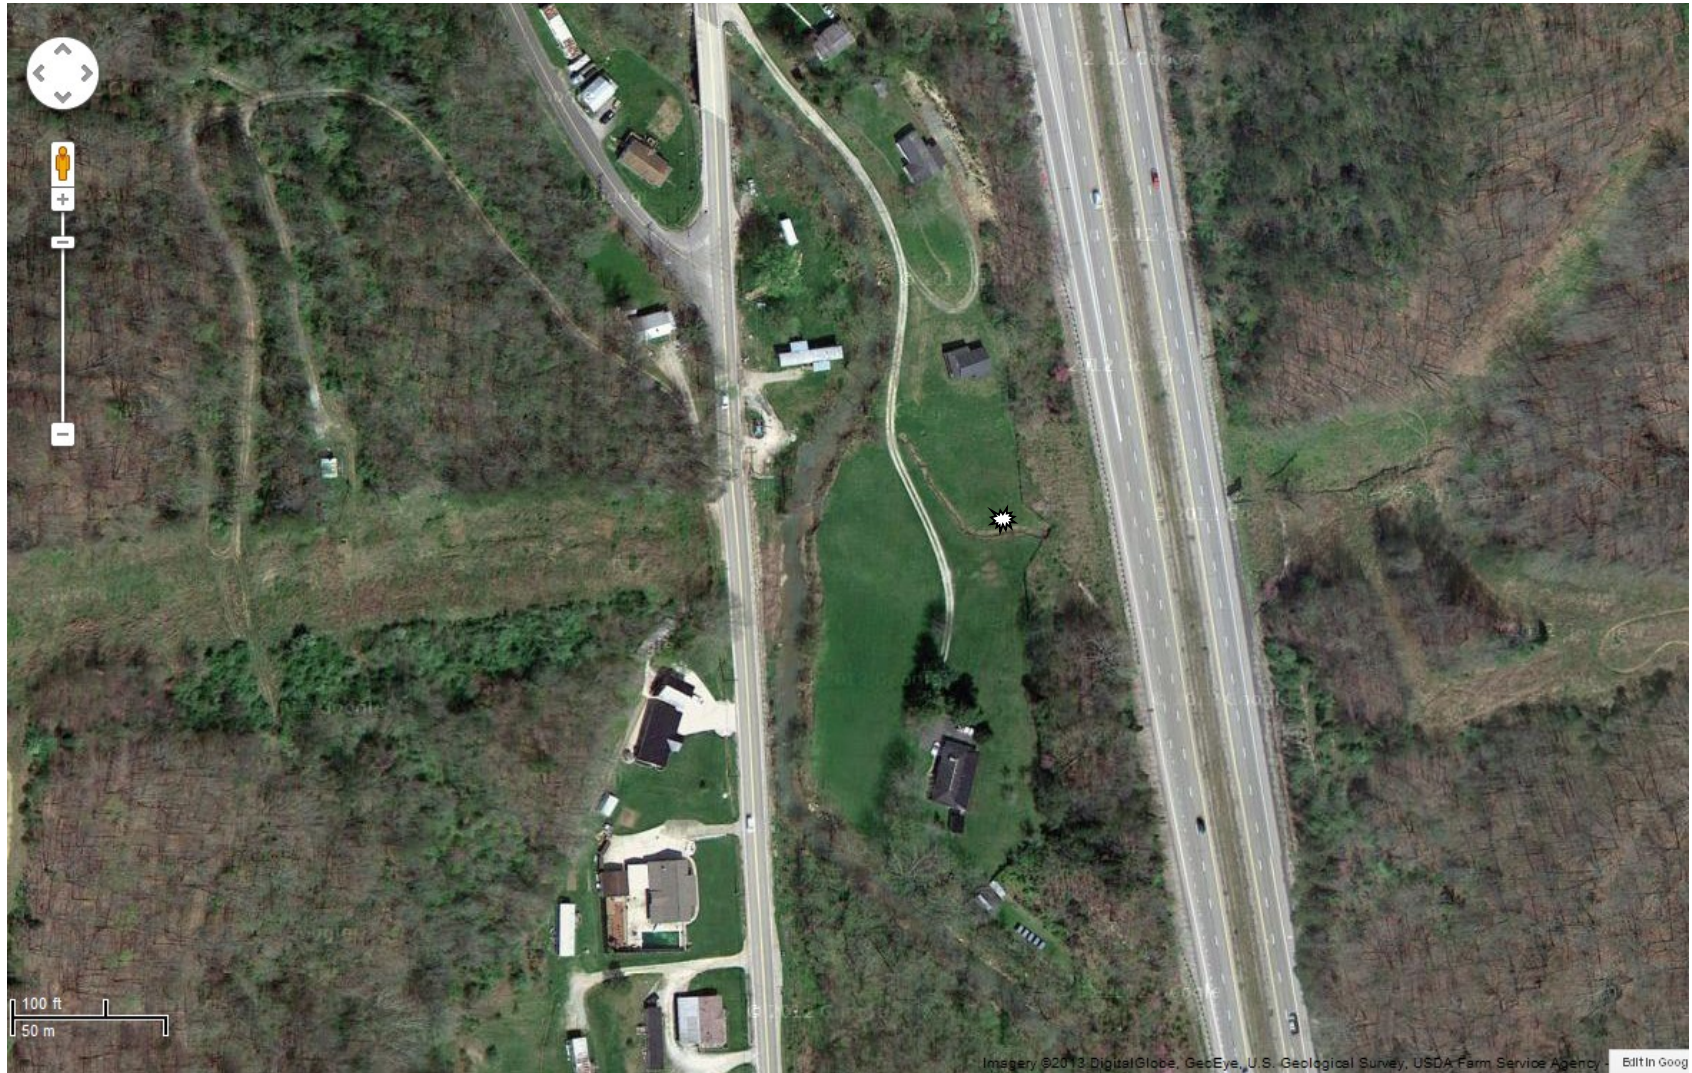
**Figure 13 - House destroyed Sissonville, West Virginia . This house is one not replaced as shown in Figure 8.**

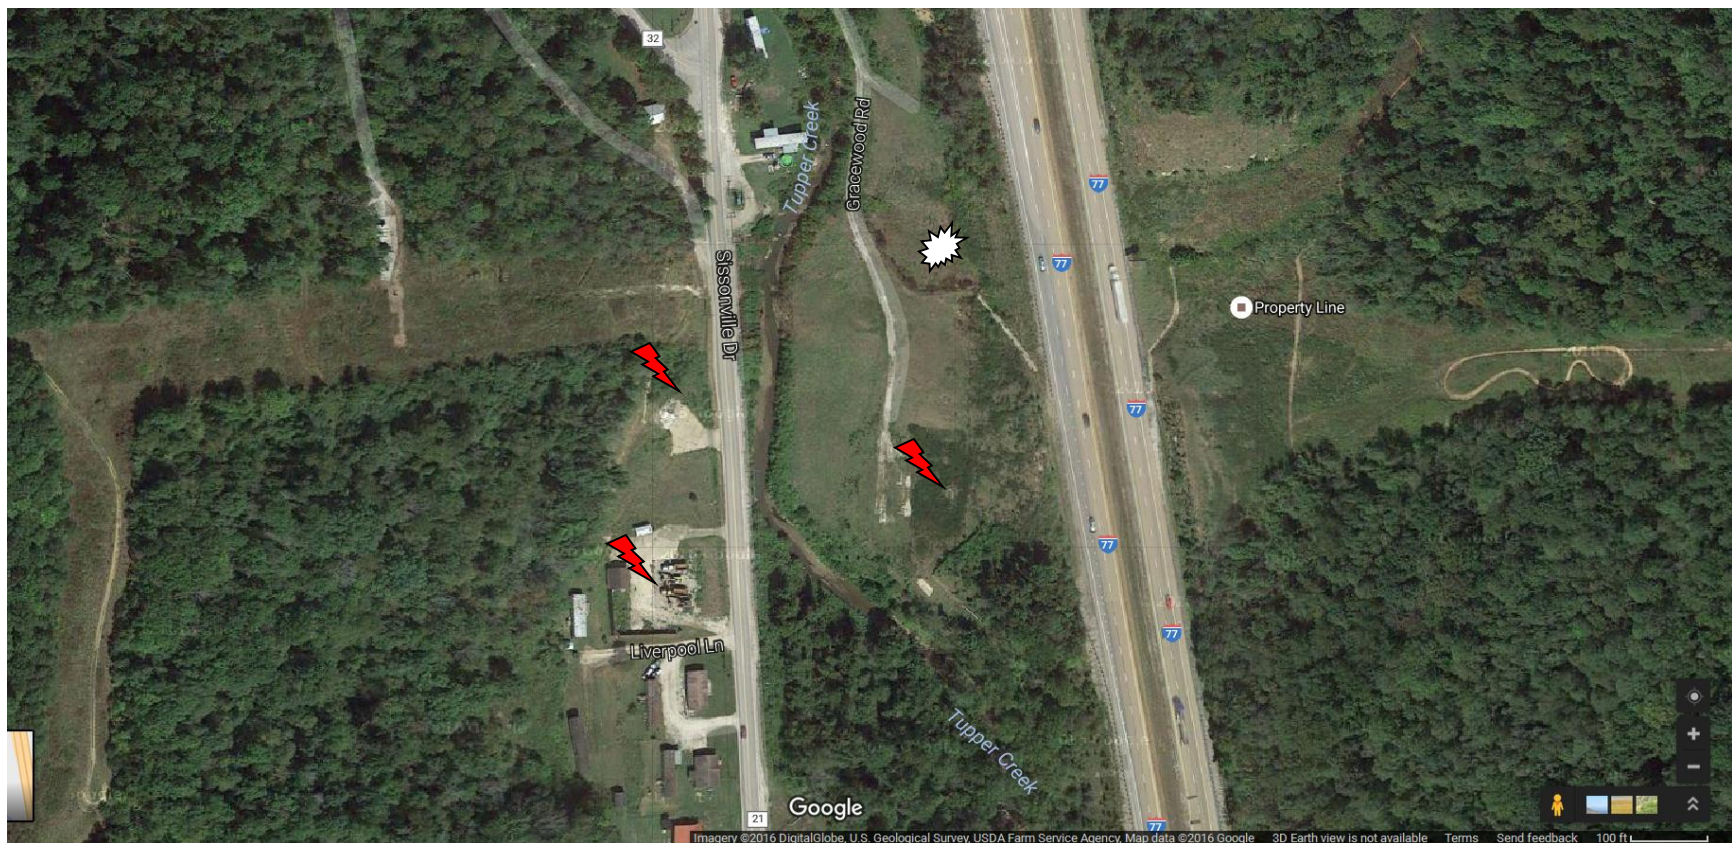
**Figure 14 Aerial View Before Pipeline Rupture, Sissonville, West Virginia (Note Proximity of Houses to Right of Way) Compare to Figure 8.**

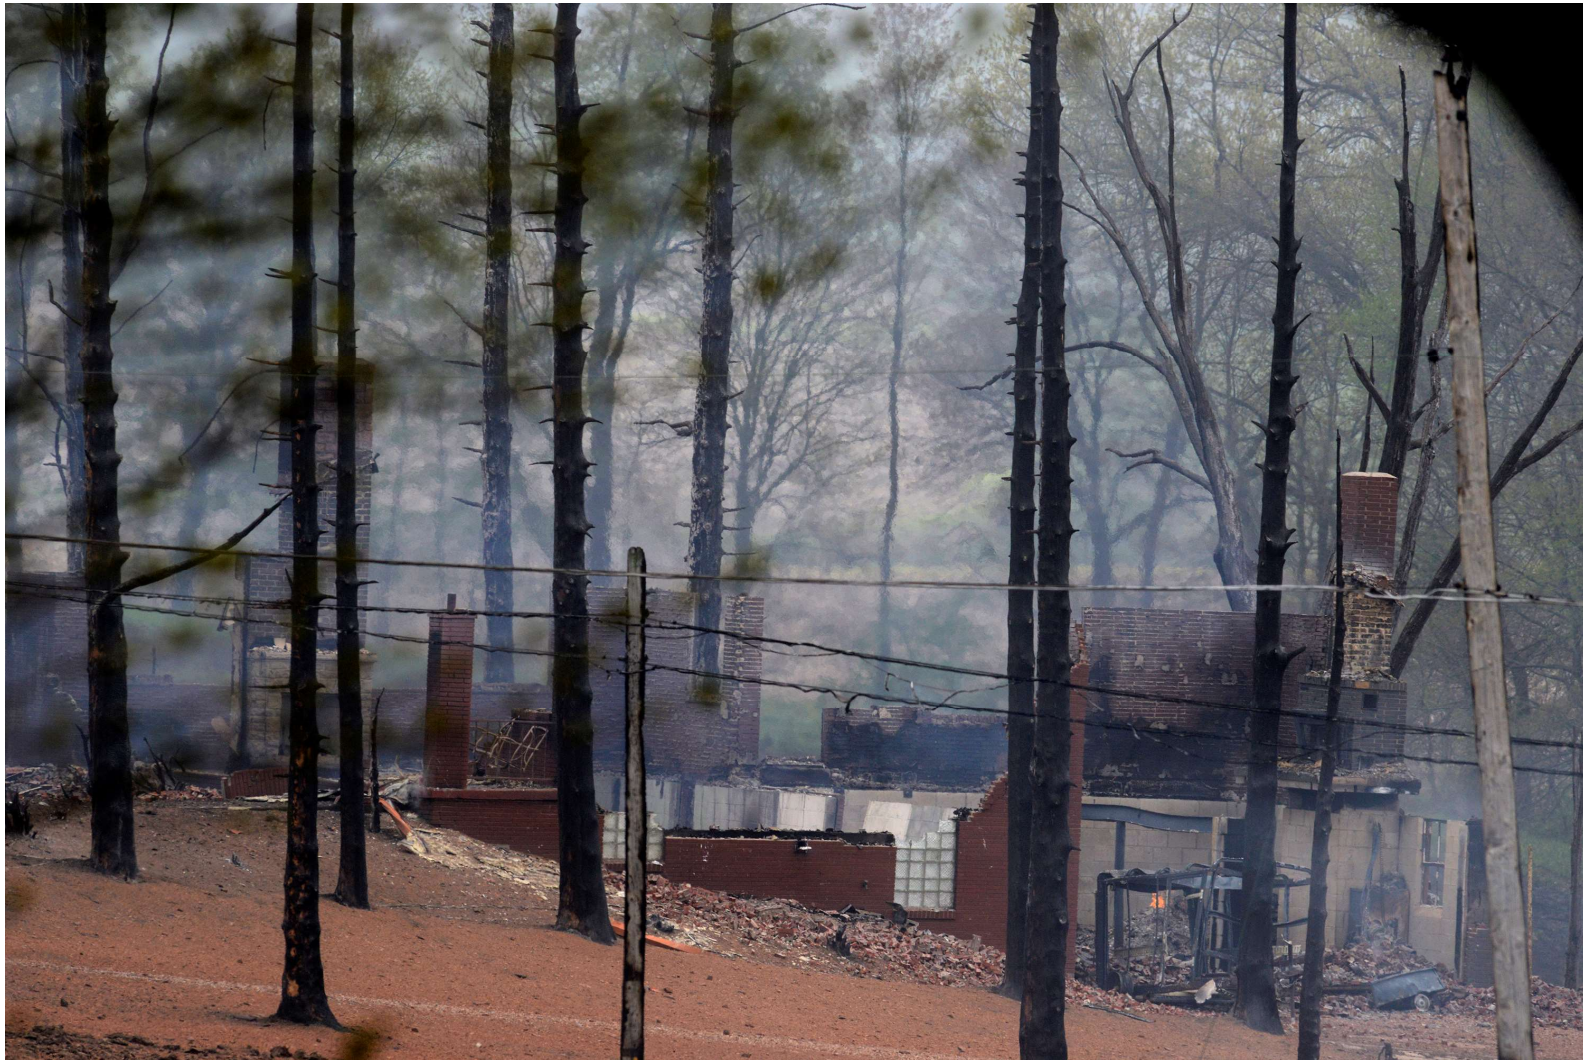
**Figure 17 - Salem Township, Pennsylvania Ref 19**

**Burned House Salem Township, Pa. Ref 19 Photo from Darrell Sapp**

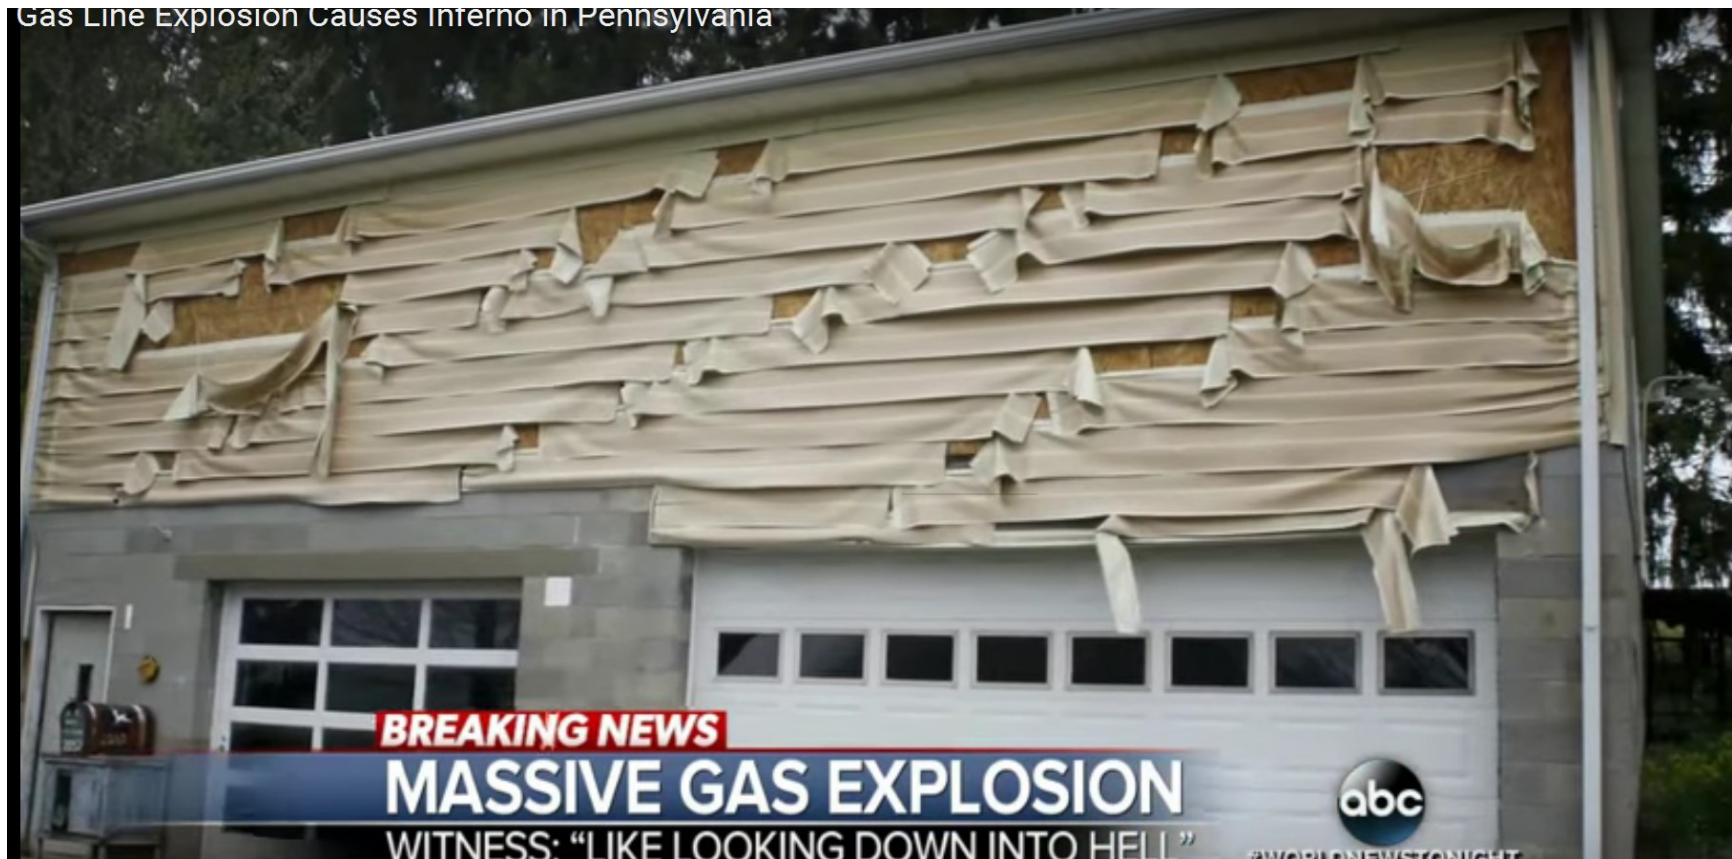
| Table 1 Summary Of Incidents | | | | | | | | |
|---|---|---|---|---|---|---|---|---|
| 19 | 4/29/2016 | Salem Township, Pa | 30 | 1050 | 895 | Aerial Visible Damage | Heat Damage | Aerial Photos News 4 Copter, House Siding Melted |

Figure 18 - Sliding melted on house 895 feet from rupture Salem Township, Pa. Ref 19
