# Historical Sample of Damage from Natural Gas Transmission Pipeline Explosions

August 14, 2017

J. E. Gillett  
Rev 0

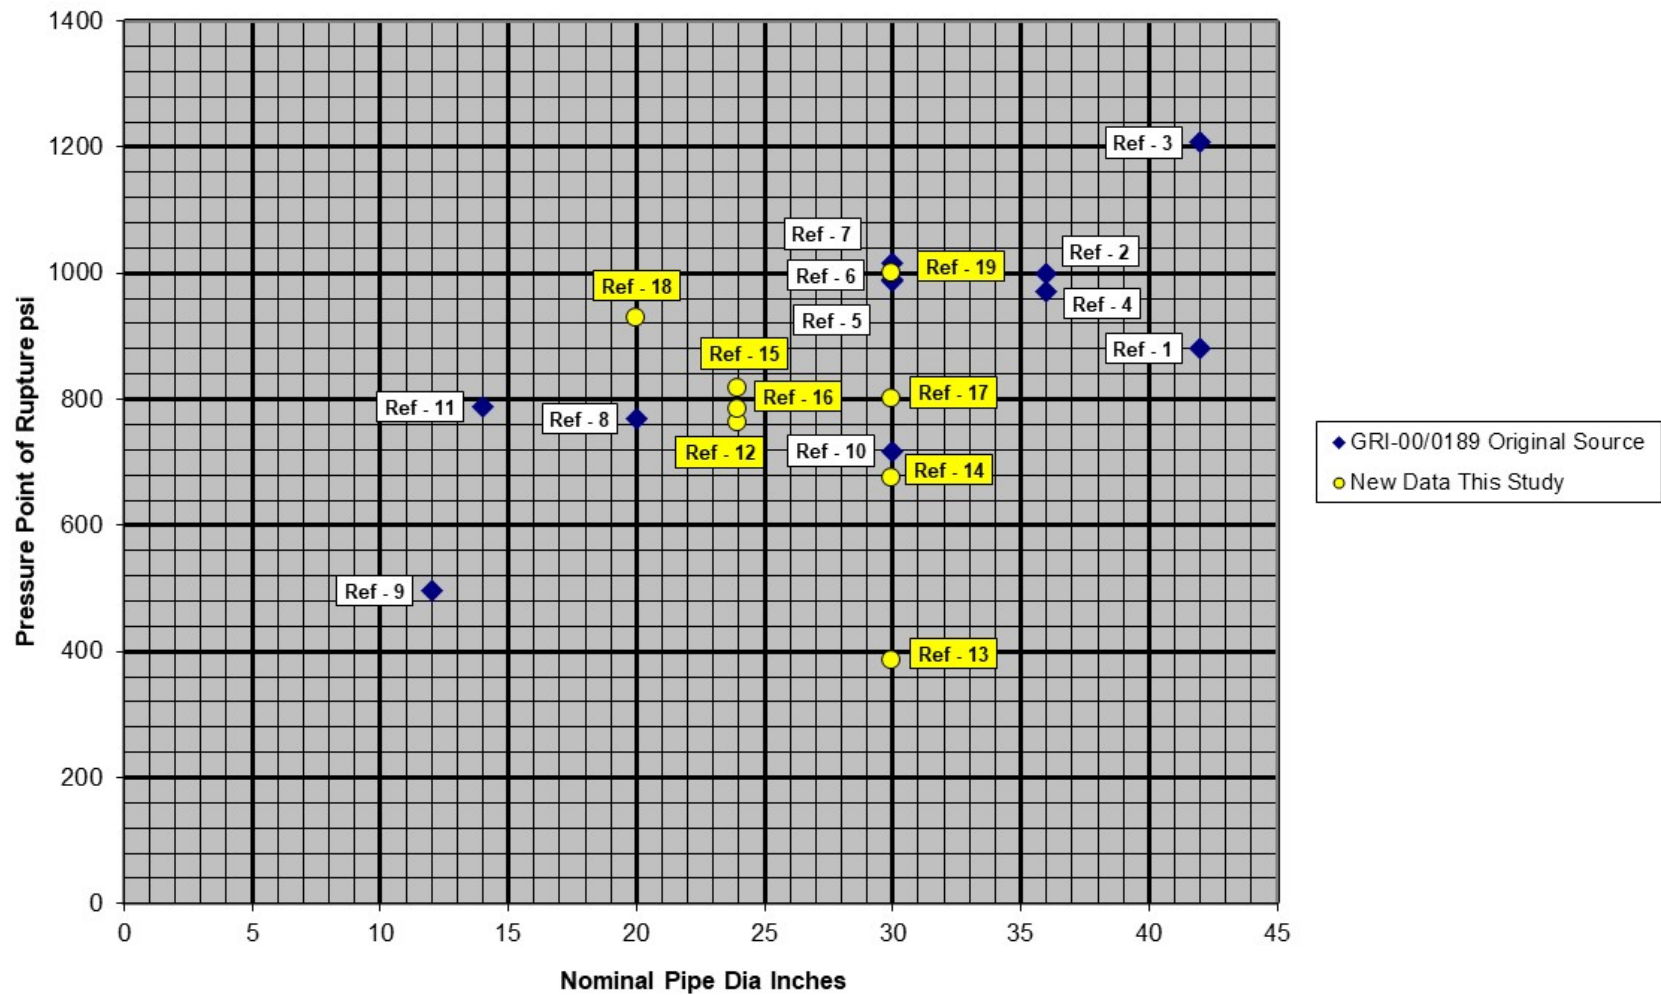
**Graph 1 - Incident Pipe Diameters and Pressures**

**Graph 1**, “Incident Pipe Diameters and Pressures” shows the range of the sample incidents with respect to pipeline diameter and pressure at the point of rupture.
